This was the leaking unit (which contains the extractor fan) on our 2006 Morello.

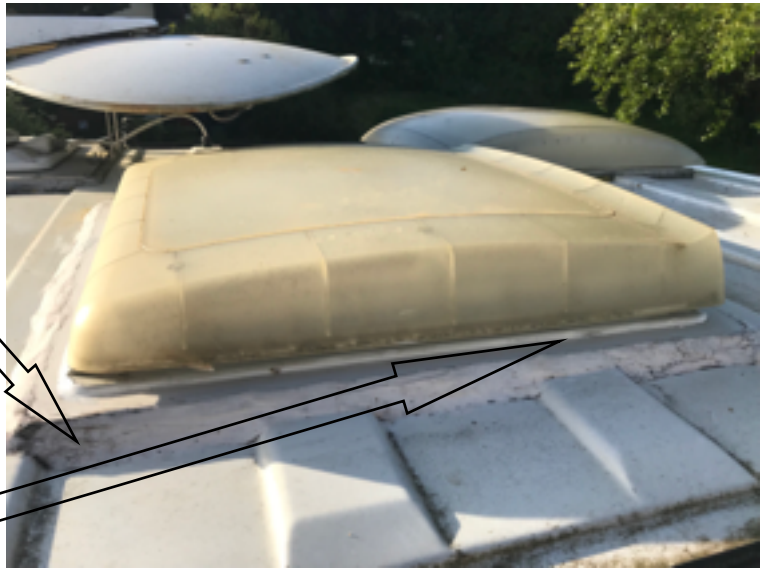
As has been pointed out it is possible to remove and replace the sealant here

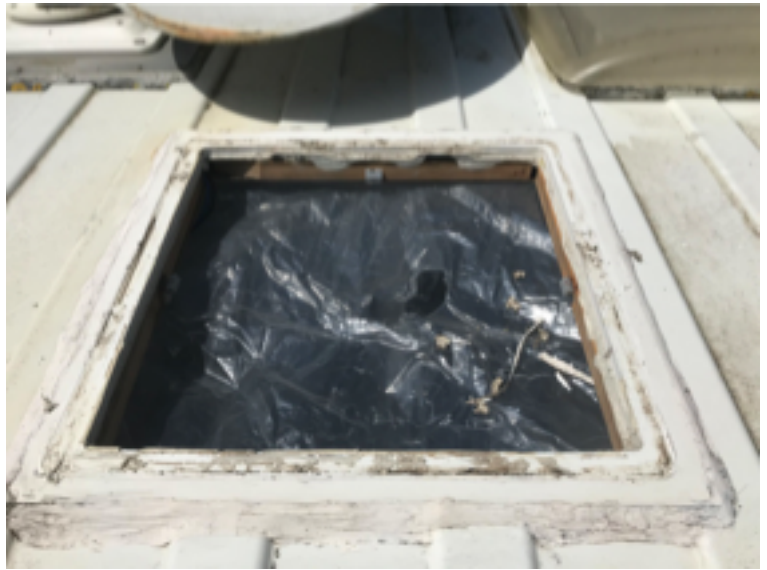
However, there is also sealant between the actual fanlight unit and the flat plate that sits on the chunky sealant that fills the roof undulations, just here.

This not so easy to deal with as it is not external but sandwiched between the fanlight and the mounting plate. A fillet of sealant all round might do the trick for a while but I'm not sure how long it will remain in place.

When the fanlight is removed it is possible to clean off the old mastic and refit the fanlight but the mastic sits in two grooves on the base of the fanlight so is quite fiddly to clean out.

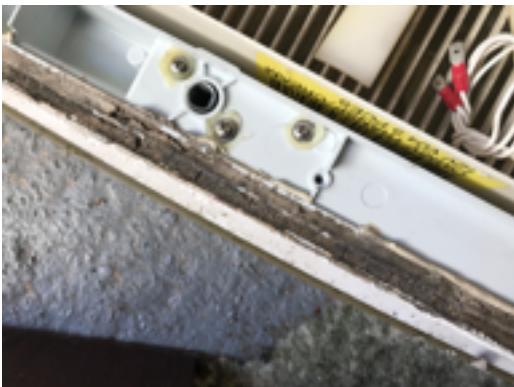
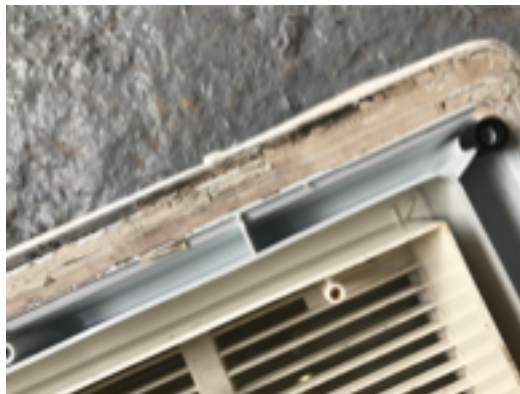
From the two photos below you can see where the sealant is black and has allowed water through as opposed to the one on the right where it was clearly still in good contact with the plate below.

As we never use the extractor fan we replace the unit completely with a new one from Leisure Shop Direct at a cost of £112.47 and are very pleased to have cured the leak as well as having much more light at the back of the van.
